# Manhole Inspection Summary

Manhole # S27C\_\_056MH

Insp Date: **12/7/07 10:56 AM**

**Location** Address: **310 FREMONT AVE**

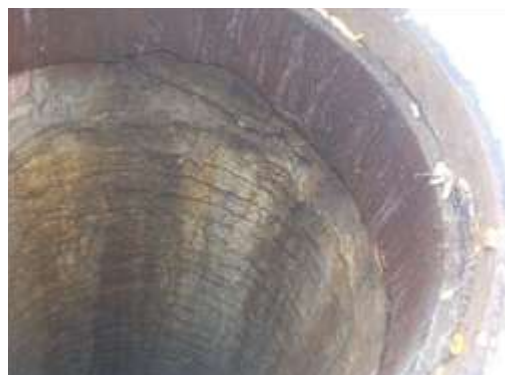
Defect 3

Infiltration: ☐ None ☐ Joint ☐ Cracks ☐ Mortar ☐ Roots ☒ Wall

CORBEL INFILTRATION

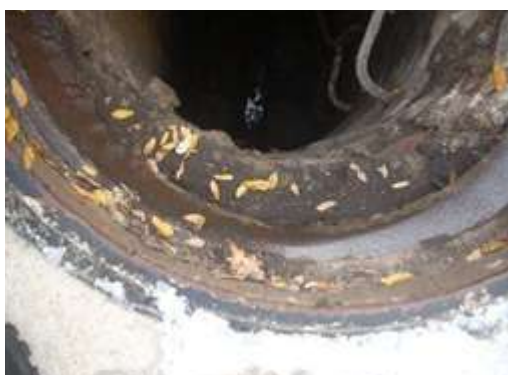
Defect 1

Offset: **4** (in.)

FRAME OFFSET

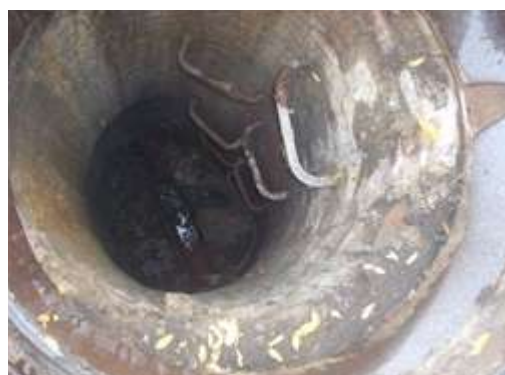
Defect 2

Count: **7** Missing: **0** ☒ Corroded

CORRODED STEPS

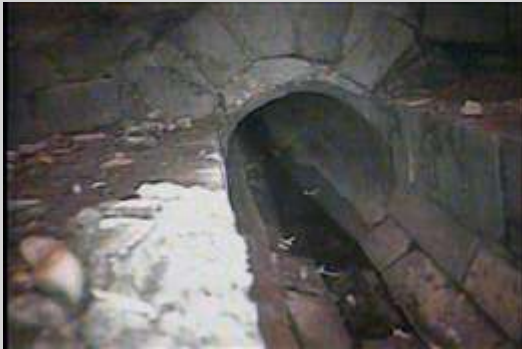
12 O'Clock Outflow

Pipe Height: **9.6** (in.) Rod and Bar (Angled)  
Pipe Material: **Clay** ☐ Pipe Lined  
Invert Depth: **13.36** (ft.) Flow Characteristics: **Slow**  
Deposits: ☒ None ☐ Mud ☐ Sludge ☐ Debris ☐ Grease  
Silt Depth: (in.) Deposits Extent:  
Infiltration: **None** Pipe Seal Cond: **Sound**

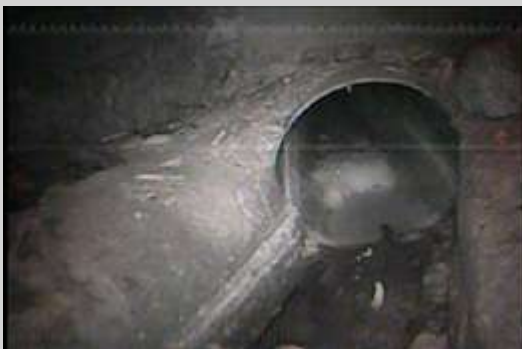
4 O'Clock Inflow

Pipe Height: **7.2** (in.) Rod and Bar (Angled)  
Pipe Material: **Clay** ☐ Pipe Lined  
Invert Depth: **12.97** (ft.) Flow Characteristics: **Slow**  
Deposits: ☐ None ☐ Mud ☒ **Sludge** ☐ Debris ☐ Grease  
Silt Depth: **3** (in.) Deposits Extent: **Medium**  
Infiltration: **None** Pipe Seal Cond: **Sound**

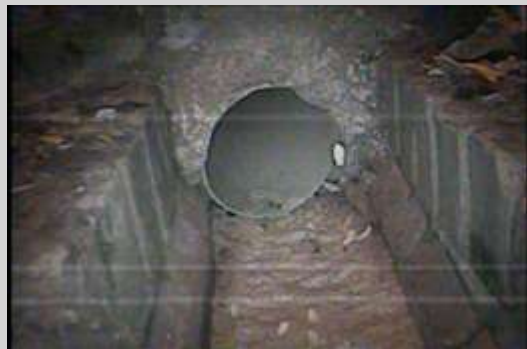
6 O'Clock Inflow

Connects To: **Stub connection / abandoned**
